Residential Inspection Report

**4108 Walnut Street
Largo, Florida**

04/17/2005

2109

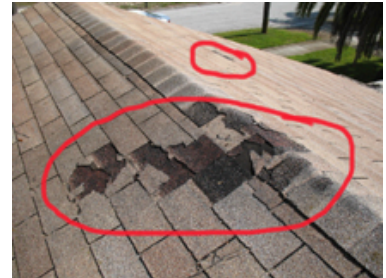
- **Repair:** Repairs to the roofing are needed. There are damaged or missing roofing materials throughout field of gable roof. Further evaluation and repair is recommended at this time.

- **Repair:**
 1. Repair damaged or missing roofing materials throughout field of gable roof.
 2. Replace damaged drain waste vent (DWV) pipe roof penetration flashing on south and west exposure of gable roof.

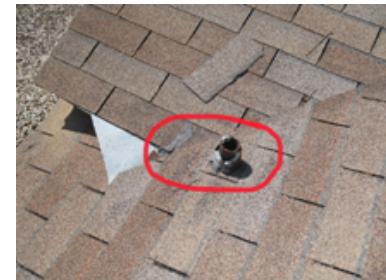
- **Repair:** There are damaged drain waste vent (DWV) pipe roof penetration flashings on south and west exposure of gable roof. This condition can allow water to infiltrate down into attic area through gap between flashing and DWV pipe. Further evaluation and replacement of DMV flashing is recommended at this time.

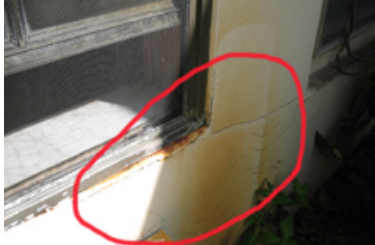
- Major Concern:** There is a settlement crack in stucco and stucco separation along south exterior wall off closed in back porch. Inspector could not determine at time of inspection the extent of damage to interior of wall. Destructive testing would have to be employed to determine damage. Further evaluation and repair is recommended at this time.
-

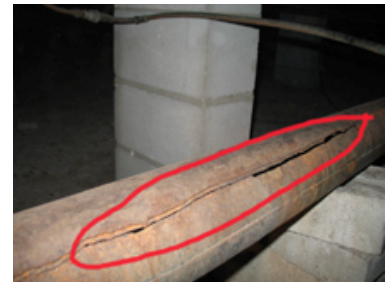
- **Major Concern:** The main cast iron waste pipe located under main bathroom is cracked. This condition will allow wastewater to leak out into crawl space area and allow dangerous sewer gas to enter crawl space area.

- **Major Concern:** Repair water leak from master bathroom shower pan.
- **Major Concern:** Repair or replace main cast iron waste pipe located under main bathroom.

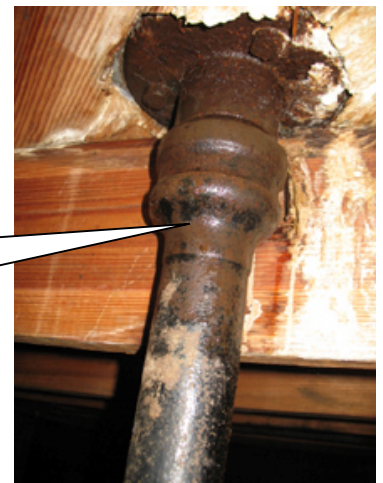
- **Major Concern:** There is a water leak from master bathroom shower pan indicated by water leaking down into crawl space area under house.

Water observed running down exterior of master bathroom shower drainpipe into crawl space under house.

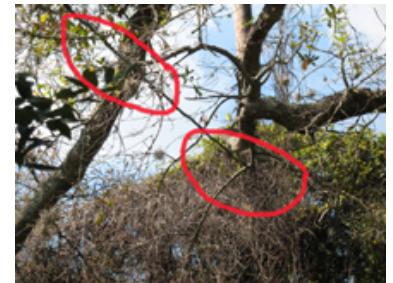
- **Repair:** There are limbs from tress rubbing up-against electric service drop wires along west side of property. This condition can cause tree limbs to damage or break electrical service drop wires during windy weather conditions causing electrical service disruption and possible shock hazard.

Repair: Trim back tree limbs that are rubbing up-against electric service drop wires along west side of property.
