Residential Inspection Report

**943 Rose Drive
Clearwater, Florida 34765**

02/16/2008

2209

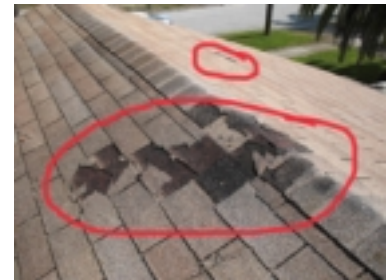
- **Repair:** Repairs to the roofing are needed. There are damaged or missing roofing materials throughout field of gable roof. Further evaluation and repair is recommended at this time.

- **Repair:**
 1. Repair damaged or missing roofing materials throughout field of gable roof.
 2. Replace damaged drain waste vent (DWV) pipe roof penetration flashing on south and west exposure of gable roof.
 3. Repair soft roof decking on flat built-up roof covering over closed in back porch area.

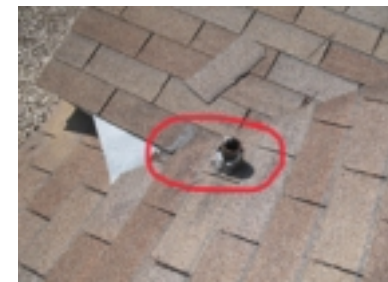
- **Repair:** There are damaged drain waste vent (DWV) pipe roof penetration flashings on south and west exposure of gable roof. This condition can allow water to infiltrate down into attic area through gap between flashing and DWV pipe. Further evaluation and replacement of DMV flashing is recommended at this time.

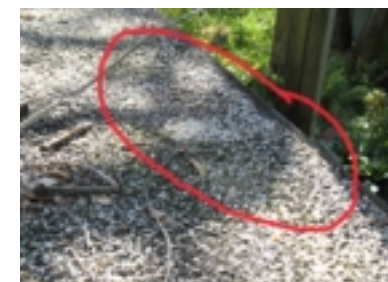
- **Repair:** The flat built-up roof covering (over back closed in porch area) is showing signs of age/weathering indicated by alligator cracking of bitumen throughout field of roof in some areas and soft roof decking along west eave area. Soft roof decking typically is an indication of water infiltration through roof covering causing roof decking underneath to break down. Further evaluation and repair of soft roof decking is recommended at this time.

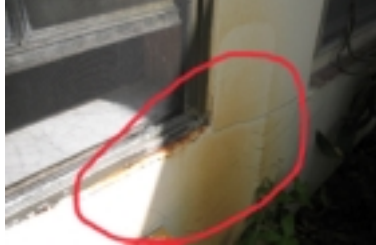
- **Major Concern:** There is a settlement crack in stucco and stucco separation along south exterior wall off closed in back porch. Inspector could not determine at time of inspection the extent of damage to interior of wall. Destructive testing would have to be employed to determine damage. Further evaluation and repair is recommended at this time.
-

- **Major Concern:** Repair of settlement crack in stucco and stucco separation along south exterior wall off closed in back porch. Destructive testing will have to be employed to determine if any damage has occurred to interior structural components of wall.

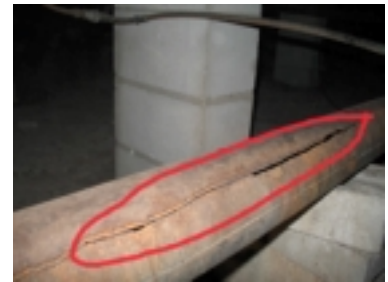
- **Major Concern:** The main cast iron waste pipe located under main bathroom is cracked. This condition will allow wastewater to leak out into crawl space area and allow dangerous sewer gas to enter crawl space area.

- **Major Concern:** Repair water leak from master bathroom shower pan.
- **Major Concern:** Repair or replace main cast iron waste pipe located under main bathroom.

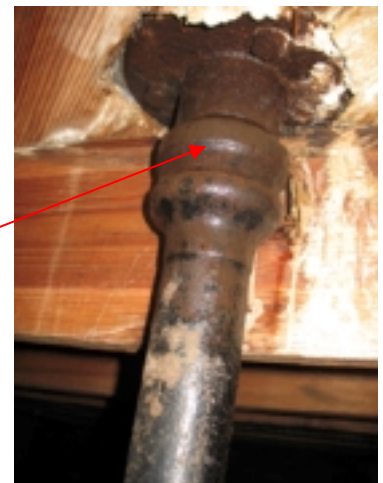
- **Major Concern:** There is a water leak from master bathroom shower pan indicated by water leaking down into crawl space area under house.

Water running
down exterior of drain pipe
under shower in crawl space.

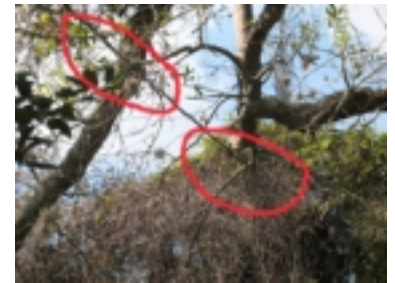
- **Repair:** There are limbs from tress rubbing up-against electric service drop wires along west side of property. This condition can cause tree limbs to damage or break electrical service drop wires during windy weather conditions causing electrical service disruption and possible shock hazard.

- **Repair:** Trim back tree limbs that are rubbing up-against electric service drop wires along west side of property.
