## Townhome Inspection Report

**2456 Kay Avenue  
Tampa, FL 33701**

**Inspection Date:**

04/05/2009

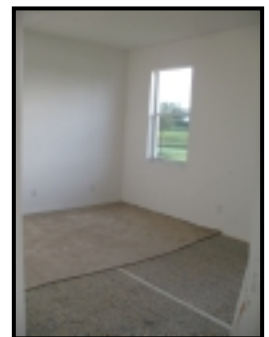
- 3) **Improve:** A section of carpeting is missing from master bedroom.

Master bedroom flooring.

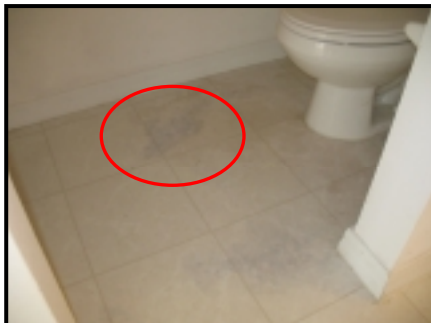
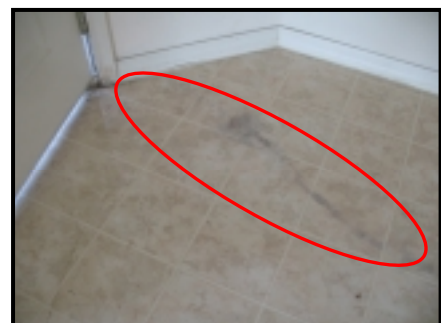
**Improve:** Vinyl flooring in master bathroom and entry foyer is discolored in some areas. There are a number of conditions that can result in discoloration of vinyl (moisture in underlayments, non-recommended adhesives, or contaminants). Discoloration appears to be around plumbing fixtures and/or areas where moisture infiltration may occur. There was no abnormal moisture content in discolored areas when probed with a moisture meter at time of inspection. Inspector could not determine at time of inspection if discoloration of vinyl flooring is the result of an existing and/or prior moisture problem. To further evaluate discoloration one would have to employ destructive testing in areas in question (pulling up vinyl, pulling toilet fixture to check drain flange gasket, etc.). Destructive testing is beyond the scope of this inspection. If discoloration is of concern client should consult with a licensed contractor for further evaluation and any remedial actions necessary to be taken.

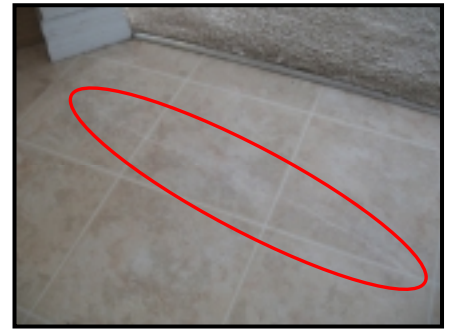
**Routine Maintenance:** There is a slight but visible indentation in vinyl flooring in kitchen area. Indentation in floor covering typically is the result of a shrinkage crack in concrete slab below showing through in the floor covering above. Shrinkage cracks are common in the concrete curing process. If indentation is of concern client should consult with a licensed contractor for further evaluation and any remedial actions necessary to be taken.

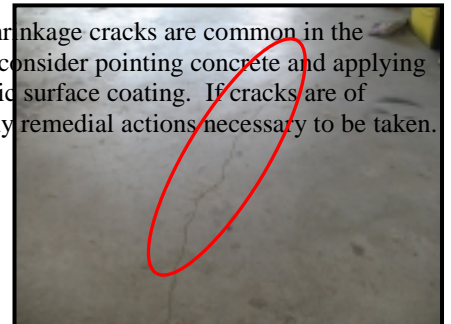
**Routine Maintenance:** There shrinkage cracks in concrete slab in garage floor. Shrinkage cracks are common in the concrete curing process. To soften the visual impact of shrinkage cracks client may consider pointing concrete and applying an elastomeric sealant in the cracks and coating the garage floor with an epoxy/acrylic surface coating. If cracks are of concern client should consult with a licensed contractor for further evaluation and any remedial actions necessary to be taken.

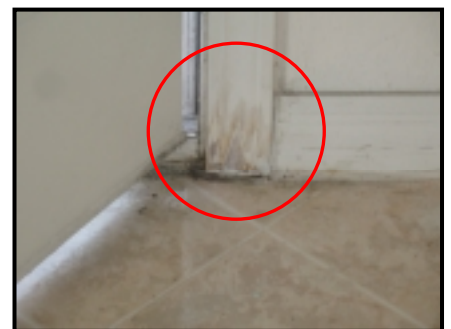
**Routine Maintenance:** There is a water stain at bottom of front door wood trim on hinge side of door jam. There was no abnormal moisture content in stained area when probed with a moisture meter at time of inspection. Inspector suspects that during certain weather conditions water may infiltrate at this point possibly contributing to the discoloration of vinyl flooring.

Front door wood trim.

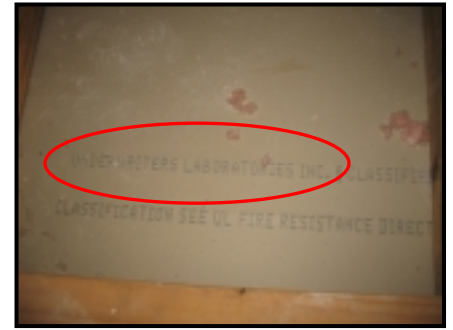
**Note:** Client requested observation of existing drywall material in home to determine if non-standard materials were used at time of construction. During observation of drywall material in attic area over garage the markings on attic side of drywall indicated a UL classification as illustrated in photo. Inspector could not determine at time of inspection if non-standard drywall was used in part or in whole in other areas throughout structure. To further evaluate type of drywall materials used throughout structure one would have to employ destructive testing to sample drywall (cut sections of drywall from walls and ceilings in different areas, observe and/or test). Destructive testing and environmental conditions are beyond the scope of this inspection. If this local observation does not satisfy concern of use of non-standard drywall client should consult with a licensed environmental professional for further evaluation.
