Condominium Inspection Report

510 Brittany Place #101
Indian Rocks Beach, FL 33763

Inspection Date:

06/26/2009

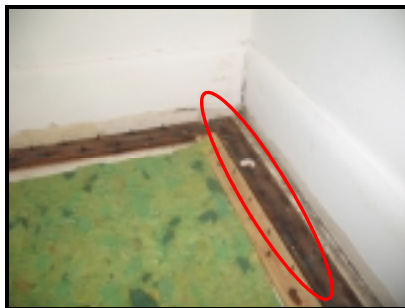
- **Note:** There appears to have been water on the floor in two areas indicated by water staining and wet rot of carpet stripes in master bedroom closet and at back porch exterior door. Refer to photos below. There was no abnormal moisture in stained areas when probed with a moisture meter at time of inspection.

Water stained carpet strips in master bedroom closet.

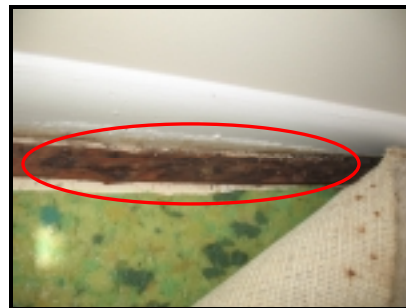
Water stained carpet strip at back porch exterior door.

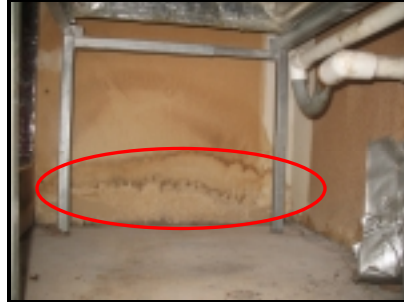
- **Note:** There are water stains on drywall under air handler in utility closet. Refer to photo below. Water stain could have possibly been caused by condensation water from air handler above. There was no abnormal moisture in stained areas when probed with a moisture meter at time of inspection.

Stain on drywall in utility closet.

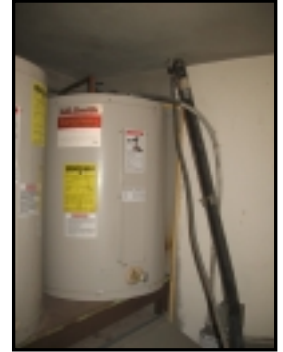
Water Supply Source:	•Public Water Supply
Interior Supply Piping:	•Copper
Waste System:	•Public Sewer System
Main Water Valve Location:	•Not Found
Drain, Waste, & Vent Piping:	•Plastic
Water Heater:	•Electric •Manufacturer: A.O. Smith •Model Number: ELJF0917 •Serial Number: MM99-0033718-917 •MFG Date: 1999
Water heater location:	•Exterior Utility room

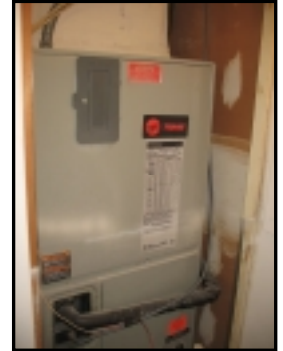
Energy Source:	•Electricity
Heating System Type:	•Central Forced Air
	•Manufacturer: TRANE
	•Model Number: TWE036C140F1
	•Serial Number: N243W6N1V
	•MFG Date: 06/1998
Heat Distribution Methods:	•Ductwork
Air Handler Location:	•Interior utility room
